## **DaliControl e64 Upgrade Tool – Firmware upgrade 1.3 Release 3      Application Note**

This application note describes the process for upgrading a device to firmware version 1.3.3 by means of the DaliControl e64 Upgrade Tool.

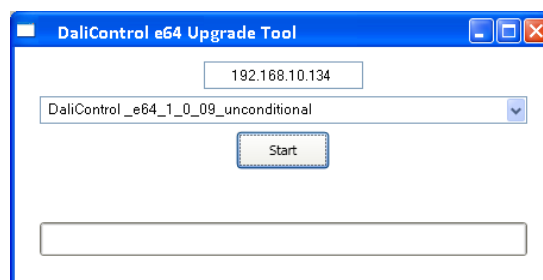
After the programme has been started the following entry window appears:

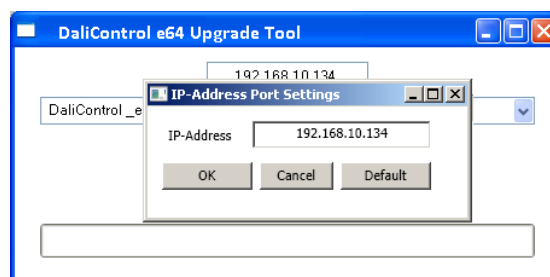
To start the upgrade, enter the IP address of the device that you would like to upgrade. Double-click on the displayed IP address (here 192.168.10.134) to open the entry field.

You can now edit the IP address and ensure it is correctly set to the value required. Press the OK button to transfer the address to the main window. Before you start the upgrade, please select the type of upgrade you would like to perform from the pull-down menu. The following types are available:

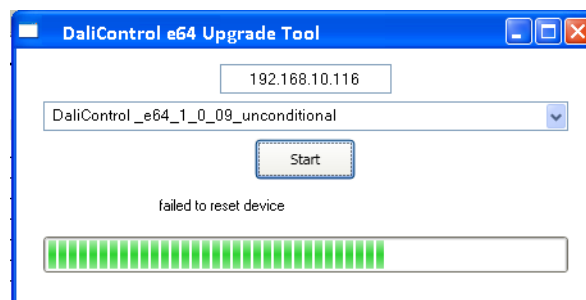
For all devices that are already equipped with firmware version 1.0.9 or higher, the reset is automatically started by the upgrade tool. If you are upgrading devices which previously contained version 1.0.8 or lower, the upgrade tool finishes with the error notification “failed to reset device”:

**Attention: In this case the device has to be re-set manually by briefly disconnecting the power supply.**

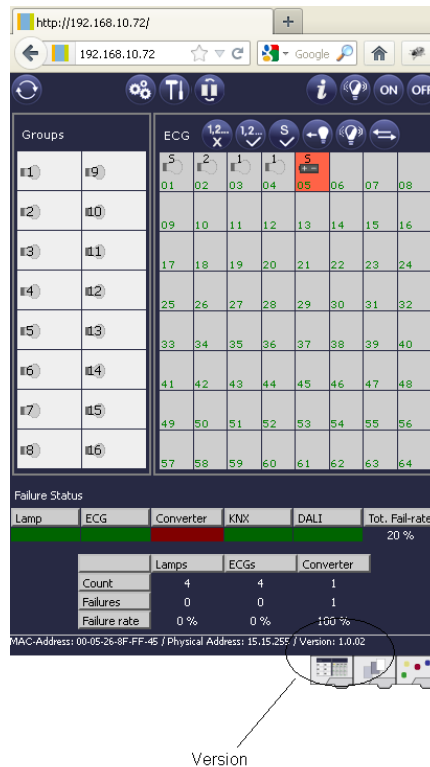
From version 1.0.2 upwards you can also check the current firmware version on the device website. The text box at the bottom of the page displays the firmware version in addition to the MAC address and the physical address of the device:
